HUNTERS POINT SHIPYARD PARCEL E EMERGENCY REMOVAL ACTION LANDFILL GAS CONTROL SYSTEM

THURSDAY 19, SEPTEMBER 2002 DAILY ENGINEER'S REPORT

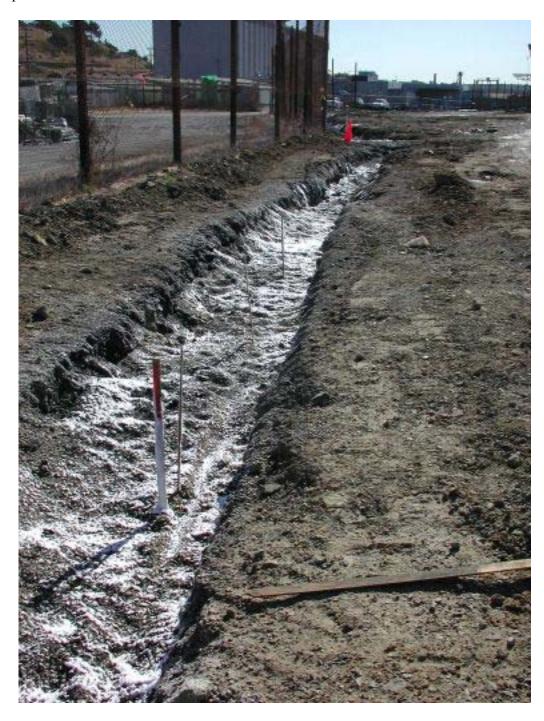
Photograph 1. Foam to Limit Emissions in Place on Trench

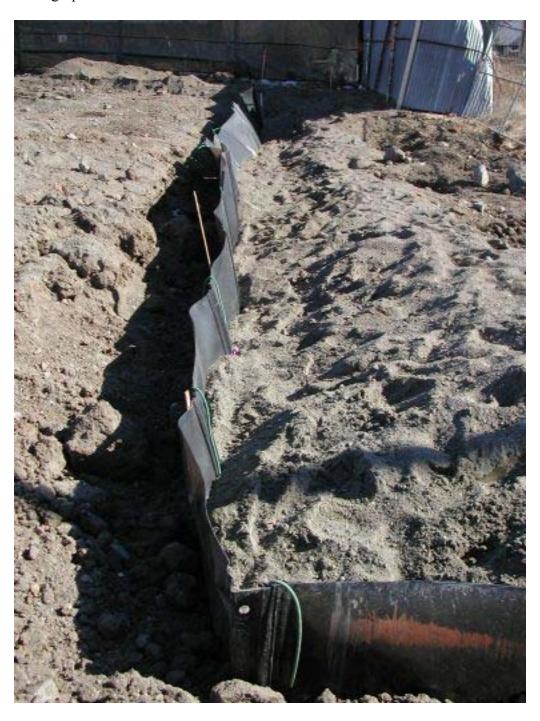
Photograph 2. Preformed Gundwall Corner Near Railroad Museum.

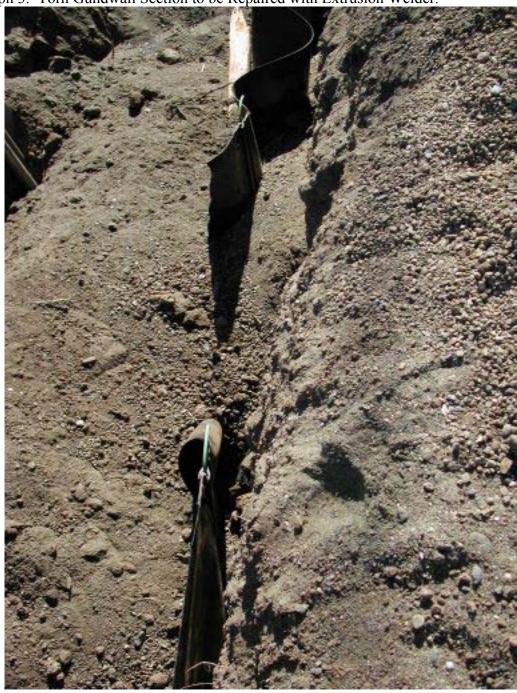
- Continued installation Gundwall. No obstructions or refusals were encountered. However, another Gundwall seam came apart near STA 1+55 and two panels had to be removed by excavator.

Photograph 3. Torn Gundwall Section to be Repaired with Extrusion Welder.

- Cooper Crane is attempting to get an extrusion welder to repair the damaged sections of Gundwall.
